**VILLAGE OF BIG VALLEY**  
**AGENDA of the REGULAR COUNCIL MEETING**  
**Held at the Village of Big Valley Administration Building**  
**Monday, August 19, 2024 – 7:00 p.m.**

This report has been prepared by MPE a division of Englobe (MPE), for the sole use of the Village of Big Valley. Any use that a third party makes of this report, or reliance on or decisions made based upon it is the responsibility of the third party. MPE accepts no responsibility for damages, if any, suffered by a third party as a result of decisions made or actions taken based upon this report. This report represents MPE's best judgement, based on the information available at the time of report preparation. Use of this report is subject to the appended Terms of Reference.

MPE a division of Englobe (MPE) was retained by the Village of Big Valley (Client) to investigate the existing Big Valley Sewage Lagoon approximately 1 km south of the Village. It is understood that the Village is looking to address safety concerns surrounding the lagoon facility and dam safety deficiencies of the lagoon. Authorization to proceed with the work outlined in the proposal by MPE was received by Mrs. Colleen Mayne of the Villa

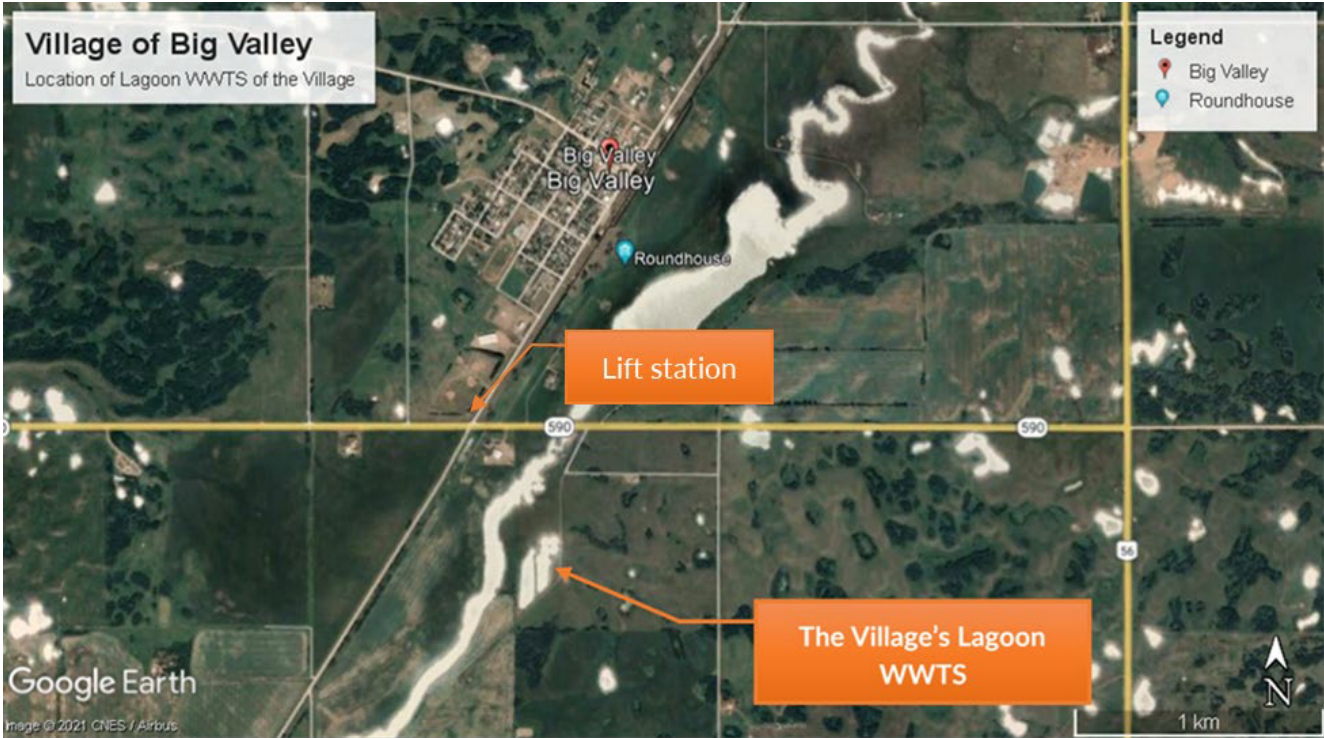
Figure 2-2  
Existing Village of Big Valley Lagoon Wastewater Treatment System (WWTS)  
Note: The orange arrows show wastewater flow between anaerobic (AN) cells.

Figure 2-2 shows an excerpt of the existing Village Lagoon WWTS from the design drawings.

Figure 2-2 above illustrates the direction of flow through the anaerobic cells. Under normal operation, flow entering the lagoons may be split at the inlet manhole (MN #1) allowing flows to be directed to the either inlet cells (AN1 and AN2). Interconnecting manholes, between the cells, allow for the flow to be directed between the cells. As noted during the site visit, the valves on interconnecting manholes are not functioning and the wastewater distributes between AN cells as the following:
